CORROSION ON DOOR SEAL FLANGE

TECHNICAL SERVICE BULLETIN

Reference Number(s): SI M41 02 06, Date of Issue: January 23, 2007

MINI: R50, R52, R53 (Cooper, Cooper Convertible, Cooper S)

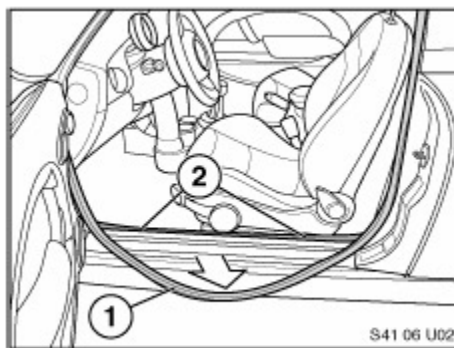
Fig. 1: Removing Lower Part Of Door Seal

The customer may complain that they have noticed areas of corrosion under the door seal, on the horizontal door flange.

Water seeping under the door seal and collecting in this area may lead to corrosion in certain heat and humidity conditions.

1. Verify the customers complaint by removing the lower part of the door seal (1) and inspecting the horizontal portion of the flange for corrosion.

3. Heavy corrosion will require sanding and painting.

The following paint and body repair should be performed to the horizontal surface of the affected flange[s] only.

- a. Prepare the surface by cleaning with a solvent based cleaner.
- b. Paper the area surrounding the work area.
- c. Use an 80 grit Roloc Bristle Disk on the affected area.
- d. Sand the affected area with P180 grit paper followed by P220 and then P320 grit paper.
- e. Blow and tack off the area to be sprayed.
- f. Use etch primer or epoxy primer followed by primer surfacer after allowing the correct flash time.
- g. Lamp (IRT) the area for 5 - 10 minutes at 80° C.
- h. Sand and feather the edge primer surfacer with wet P800 grit sand paper.
- i. Blow and tack off the affected area.
- j. Apply BMW specified base coat.
- k. Apply BMW specified clear coat.
- l. Allow a flash time of 5 - 10 minutes.
- m. Lamp (IRT) the affected area for 25 - 30 minutes at 60°C.
- n. Re-install the door seal.
